Watson's clearcoat program is available on most products and preserves the look of exposed welds with visible heat bluing, grinding, natural blemishes and manufacturing tooling marks.

# watson

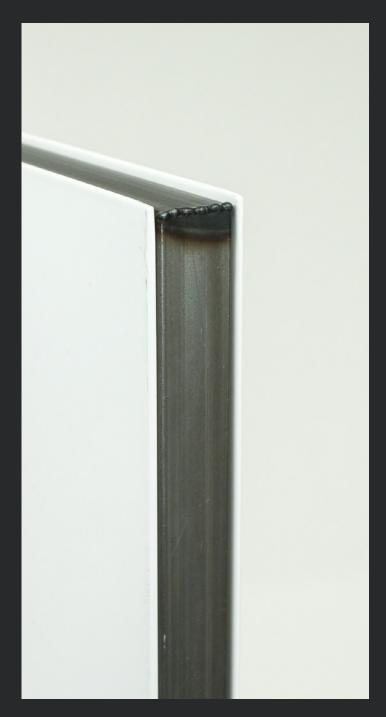
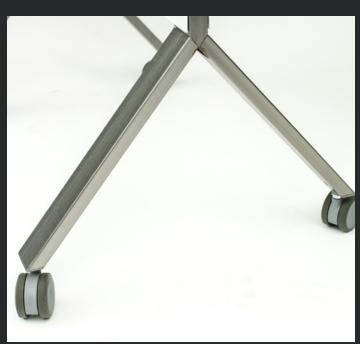
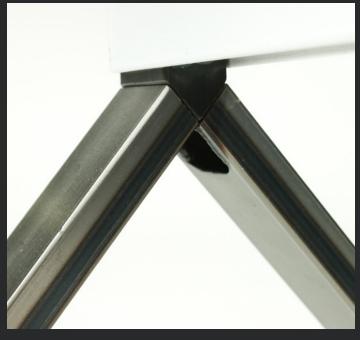
# **Etch Markerboard**

Etch Markerboard frames show visible heat coloration, and exposed beads on seam welds. Etch base tubing shows seam lines on one side (can be installed on the inside of the base legs).

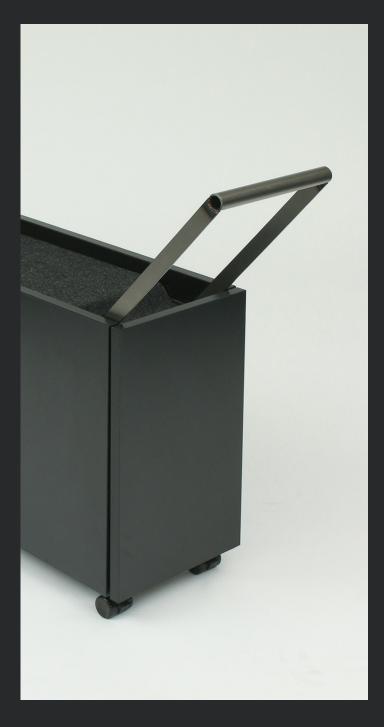
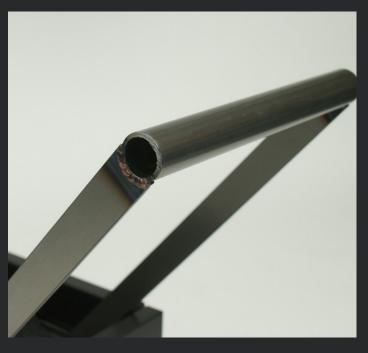
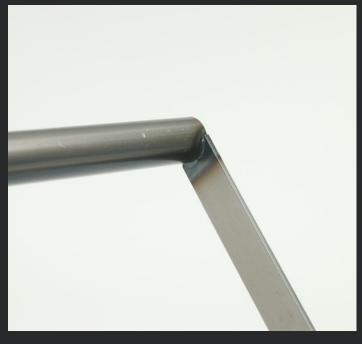
# Sidecar

The Sidecar handle shows heat coloration and visible weld beads. The handle tubing shows a seamline, placed on the underside.

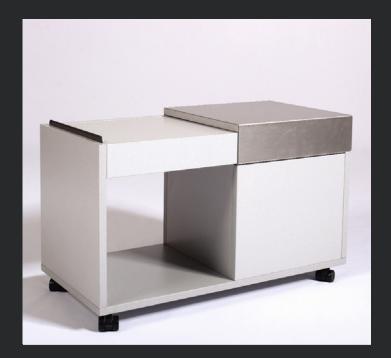
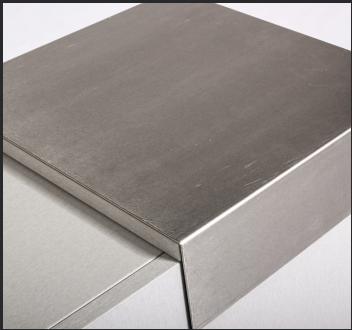
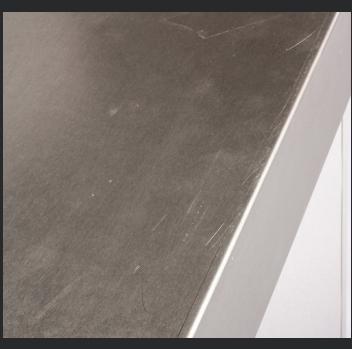
The steel Trolley surface components show natural blemishes.

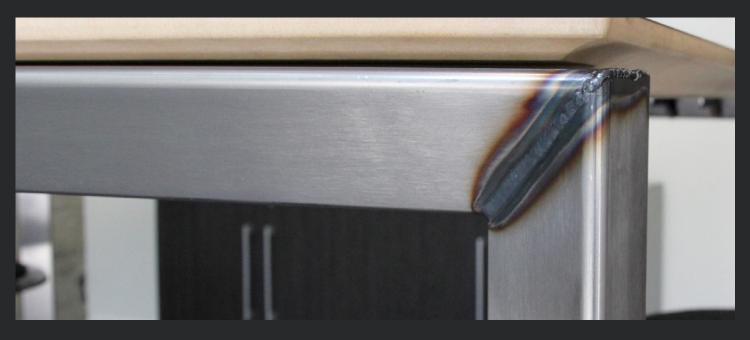
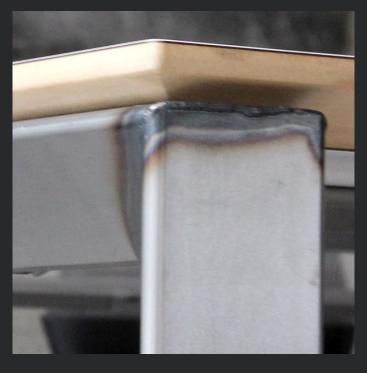
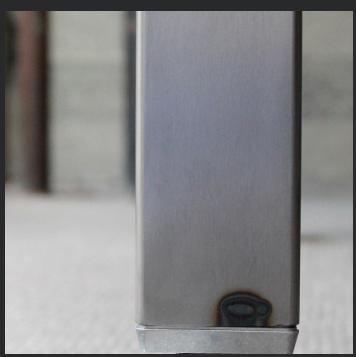
# Miro Desk + Table

Miro Desks and Meeting Tables show steel graining, natural blemishes, and weld coloration. Corners have visible weld beads and coloration.

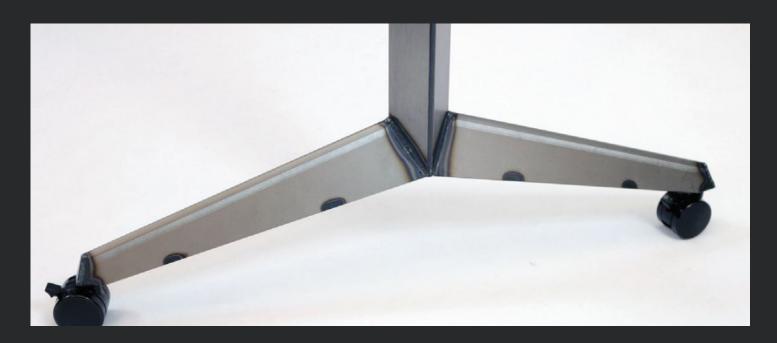
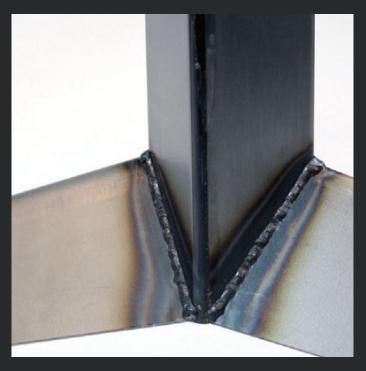
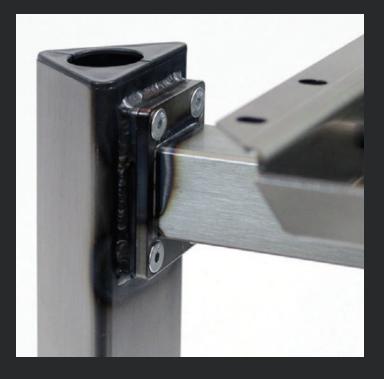
# **Miro Flip Table**

The Miro Flip table foot shows visible weld beads and coloration, as well as heat marks. The steel leg tubing shows heat coloration and natural blemishes.

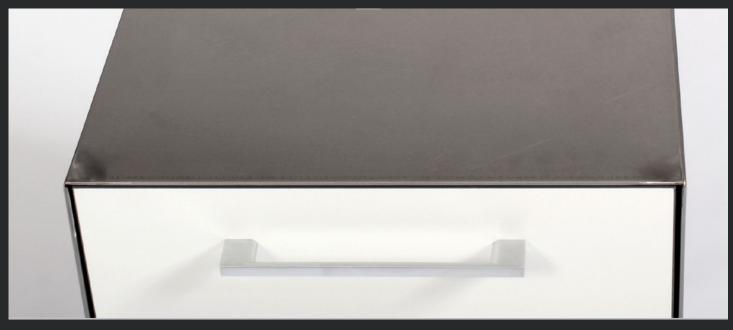
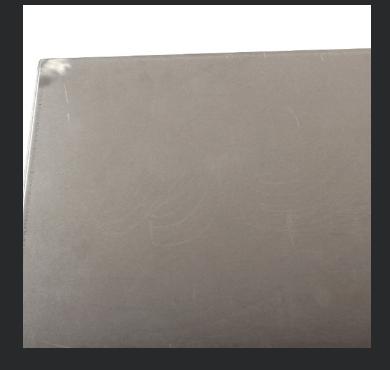
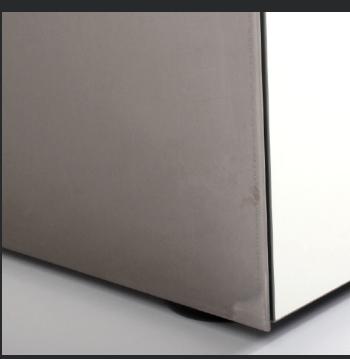
# **Miro Storage**

The Miro Storage steel case shows natural blemishes and tooling marks along the perimeter. All corners will show steel grind and graining.

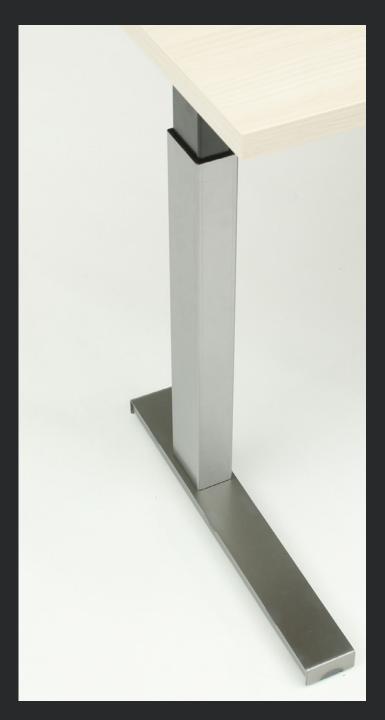
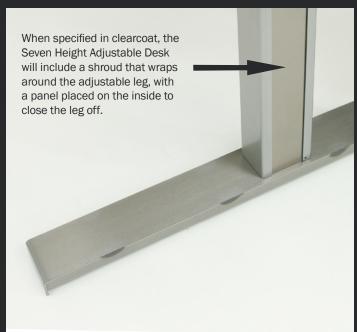
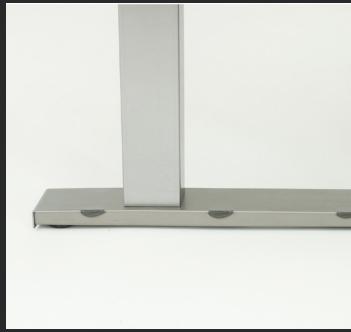
#### **Seven Desk**

The Seven Desk leg shroud shows natural blemishes, and the foo shows visible weld coloration marks and graining. Electric height adjustable desks will include black internal lifting columns.

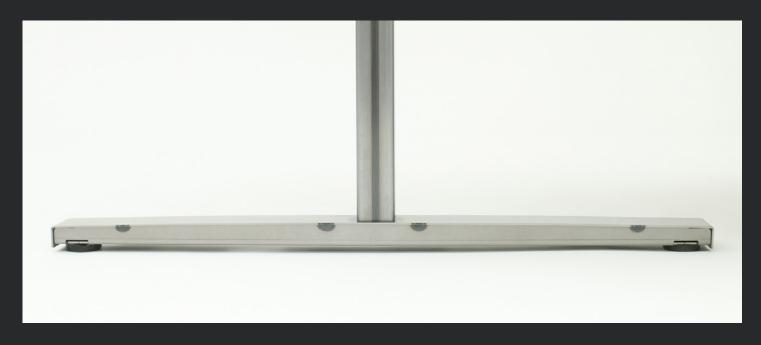
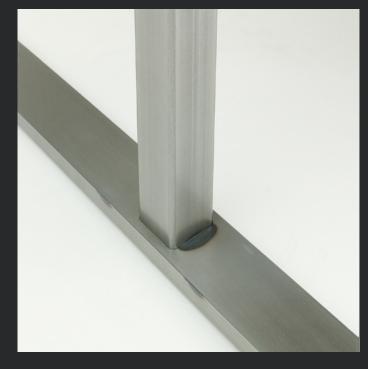
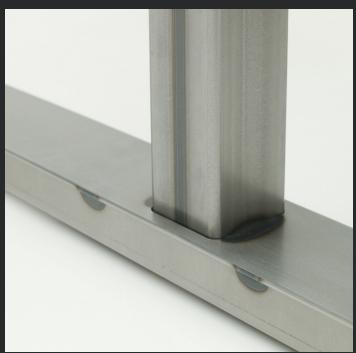
# **Seven Table**

The Seven Meeting Table leg tubing shows seam lines on one side (can be installed on inside of the leg). The foot shows visible weld coloration marks.

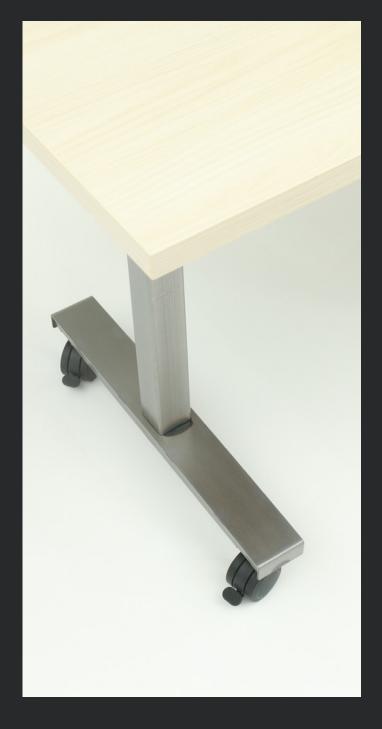
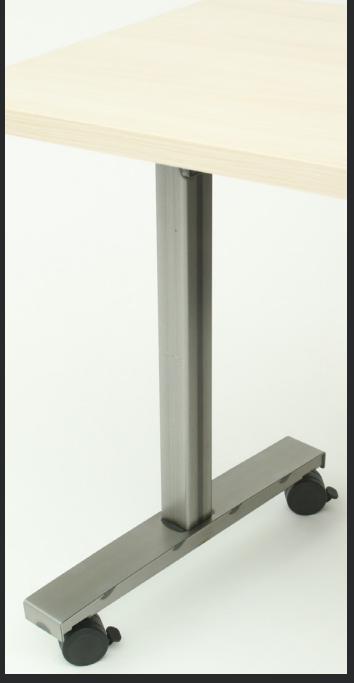
# **Seven Flip Table**

The Seven Flip Table leg tubing shows seam lines on one side placed on the inside of the leg. The foot shows visible weld coloration and graining.

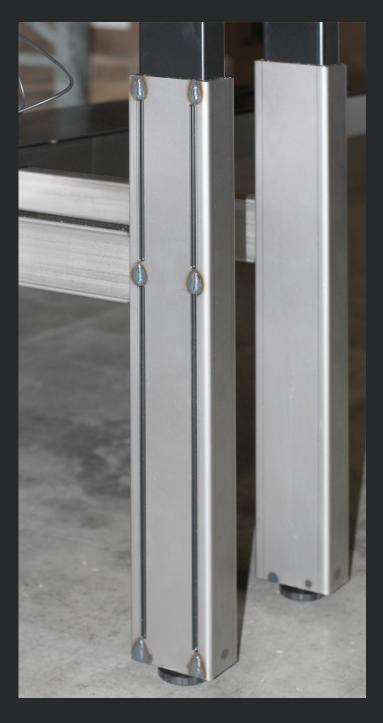
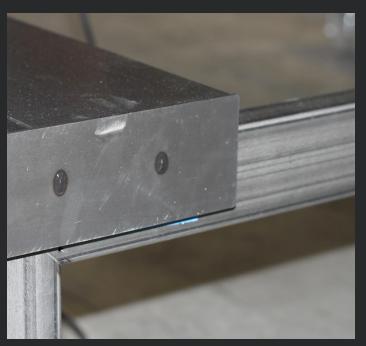
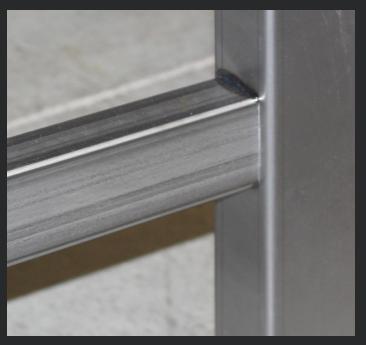
# **Seven Workbench**

The Seven Workbench base shows weld coloration and natural blemishes. The leg tubing has visible coloration and exposed beads on seam welds, placed on the inside of the legs.

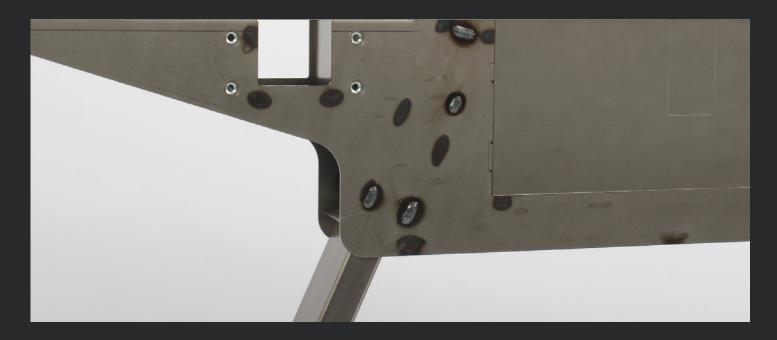
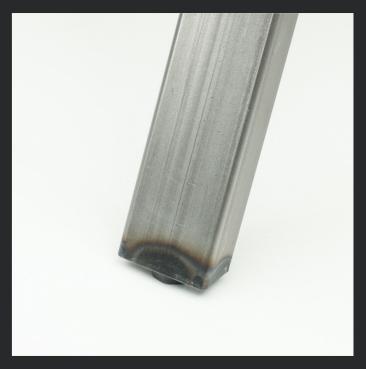
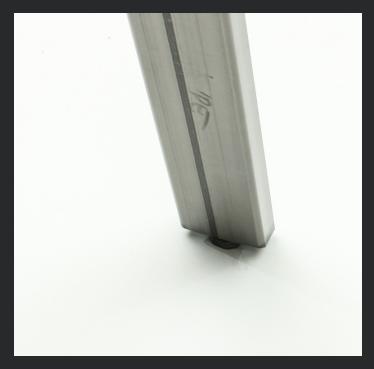
# **Tonic Bench**

The Tonic Bench end leg shows visible plug weld beads, heat coloration, and mixed materials. The leg tubing shows weld coloration and a weld seam, placed on the underside of the leg

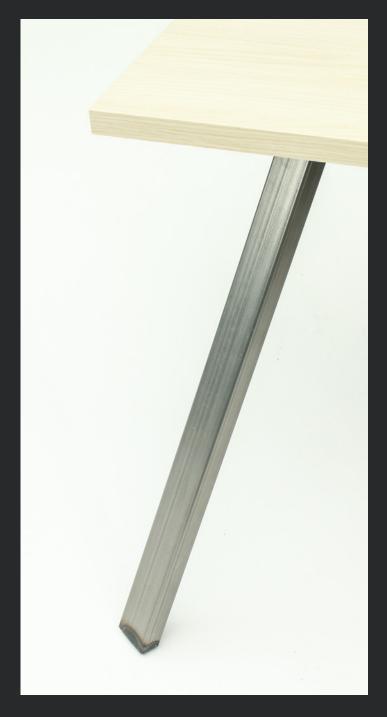
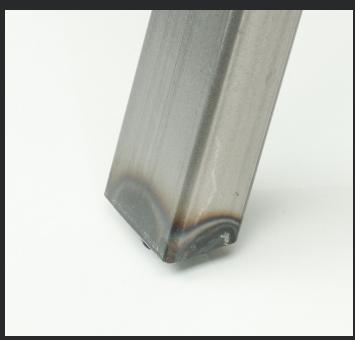
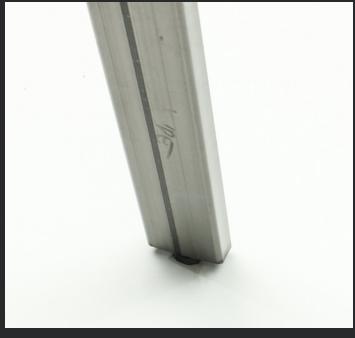
# **Tonic Table**

The Tonic Simple leg shows natural blemishes and weld coloration. A weld seam will be visible on the underside of the leg.

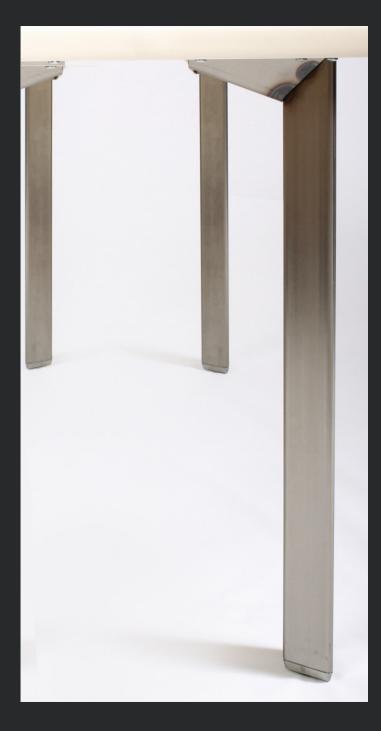
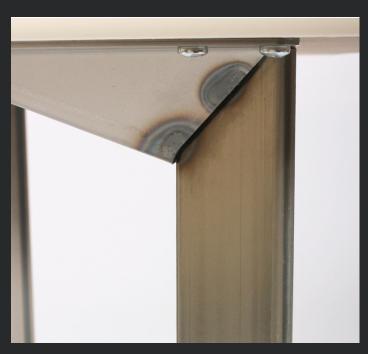
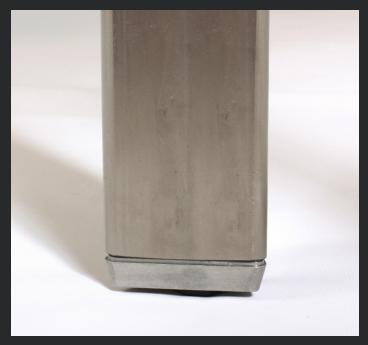
The M2 Desk shows visible weld coloration, and steel grind and graining on the leg tubing.

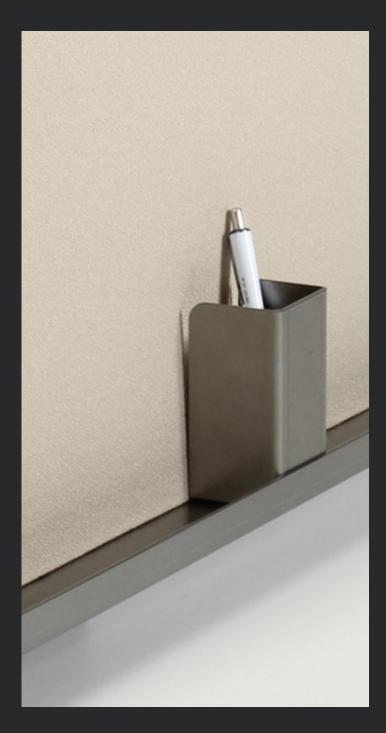
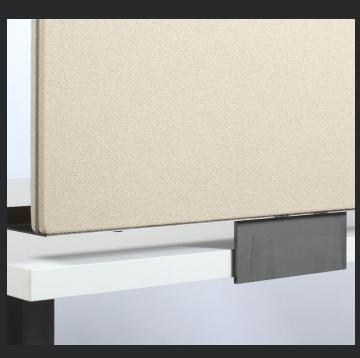
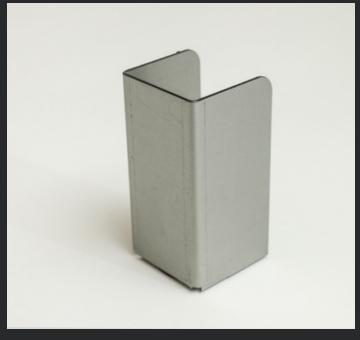
# **Seiri Screen**

The Seiri Screen shows natural blemishes on the tray and cups. The bracket detail will show visible hand graining.

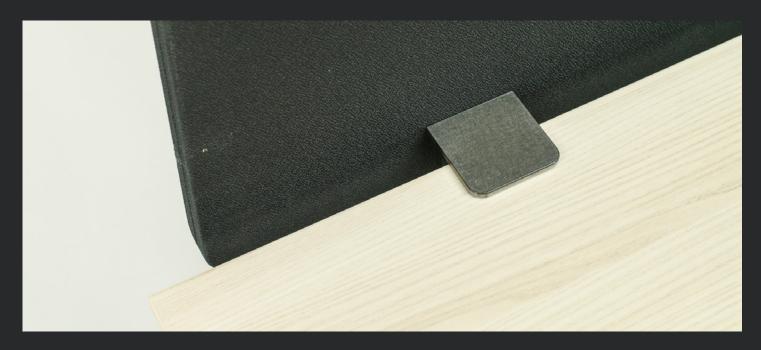
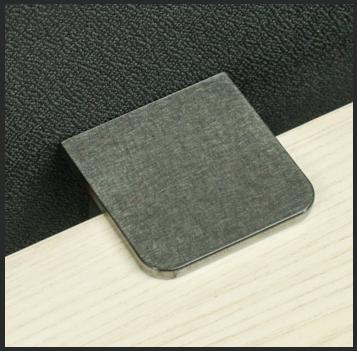
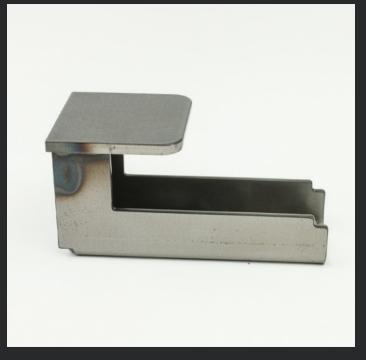
# **Jot, Tak & Pin Screens**

The Jot, Tak, and Pin Screen brackets show heat marks on the sides, and visible hand graining on the bracket surface.

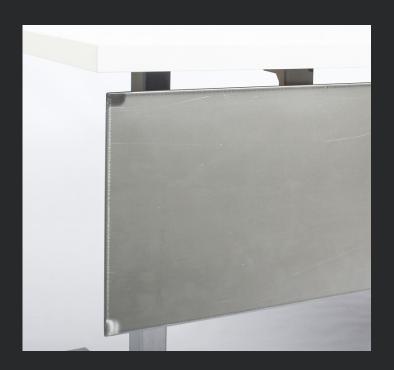
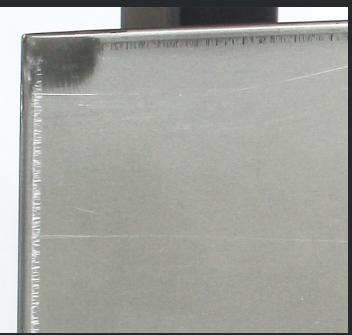
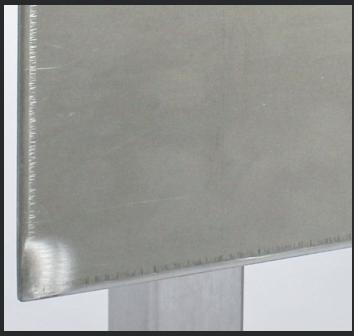
# **Steel Modesty Panel**

The Steel Modesty shows natural blemishes across the face of the panel, and tooling marks along the perimeter. Steel grind and graining are visible on all corners.

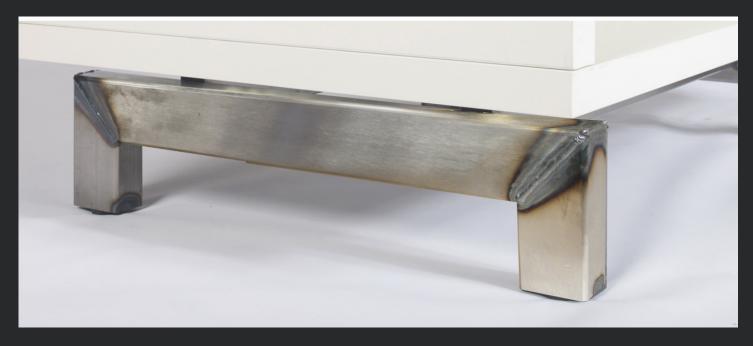
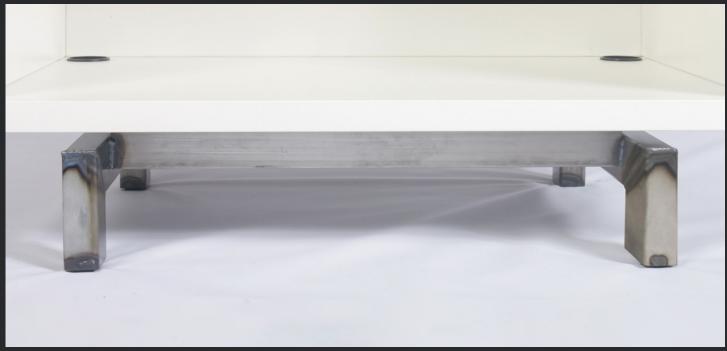
# **Zo Storage**

The Zo Denza base will show exposed weld beads, weld coloration marks, and steel grind and graining.
